MISCELLANEOUS PAPER S-69-29

EVALUATION OF HARVEY NONWELDED ALUMINUM LANDING MAT

July 1969

U. S. Army Engineer Waterways Experiment Station
CORPS OF ENGINEERS
Vicksburg, Mississippi

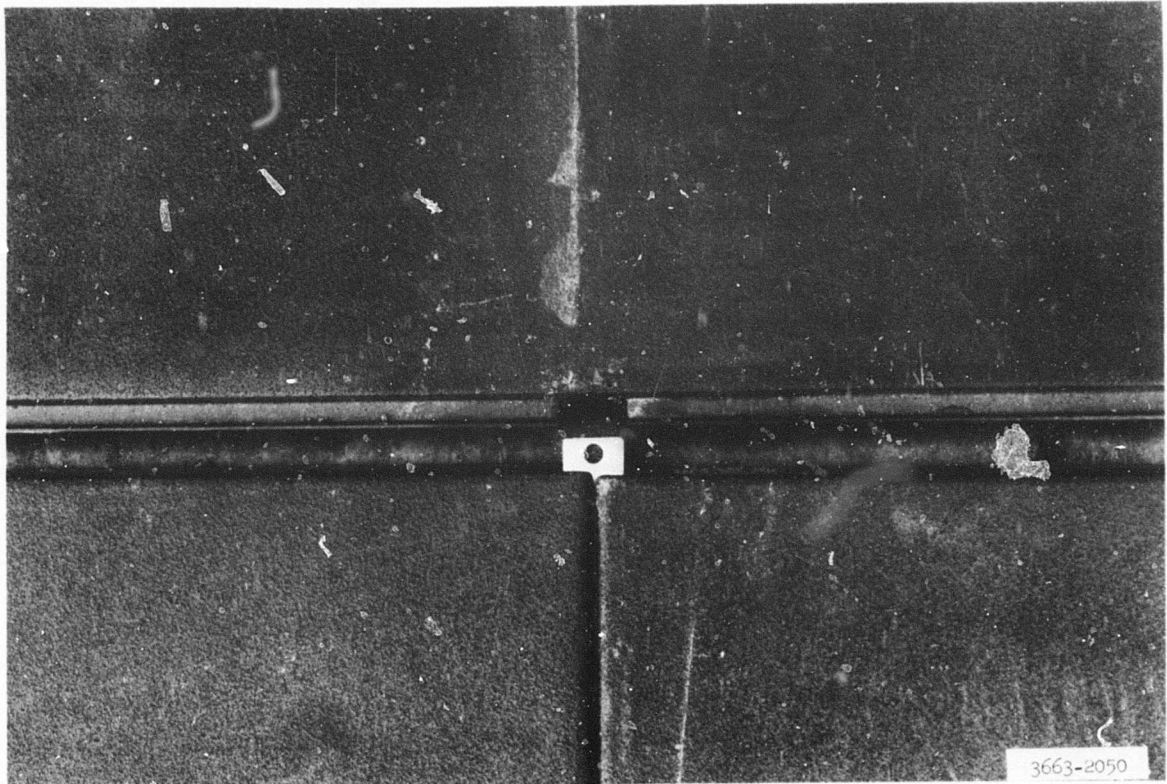
Fig. 4. View showing how the 1-in. web extension of the locking bar fits into the notched male side connector

33. Although there was only one break on the top surface of the mat after 187 coverages, this item was considered failed due to severe dishing, which caused a very rough surface. The mat in this condition is a safety hazard when used with a catapult system because of the possibility of the arresting hook on the aircraft catching mat edges rather than the cable. Photograph 16, depicting item 2 after 187 coverages, shows that there was very little lateral movement of the mat planks during the course of 187 coverages of traffic. Lateral movement of the mat was prevented in this item by the web extrusion of the locking

bar (fig. 4) fitting into the notch cut in the male side connector of the plank in the adjacent run. Fig. 7 shows a close-up of the mat damage at a notch after 187 coverages of traffic. At the end of traffic, there were only five planks with breaks such as those labeled 1 and 3 in fig. 7, and one plank with a break such as that labeled 2 in fig. 7. These breaks were approximately 1 in. in length. Other damage that was observed when the mat was taken up was 18 C-rail splits that averaged 7-3/4 in., the longest being 13-1/2 in., and 1 to 12 ribs broken in 19 planks. The maximum deformation measured in item 2 after traffic was 0.5 in. A plot of deformation along the center line of the traffic lane is shown in plate 7.

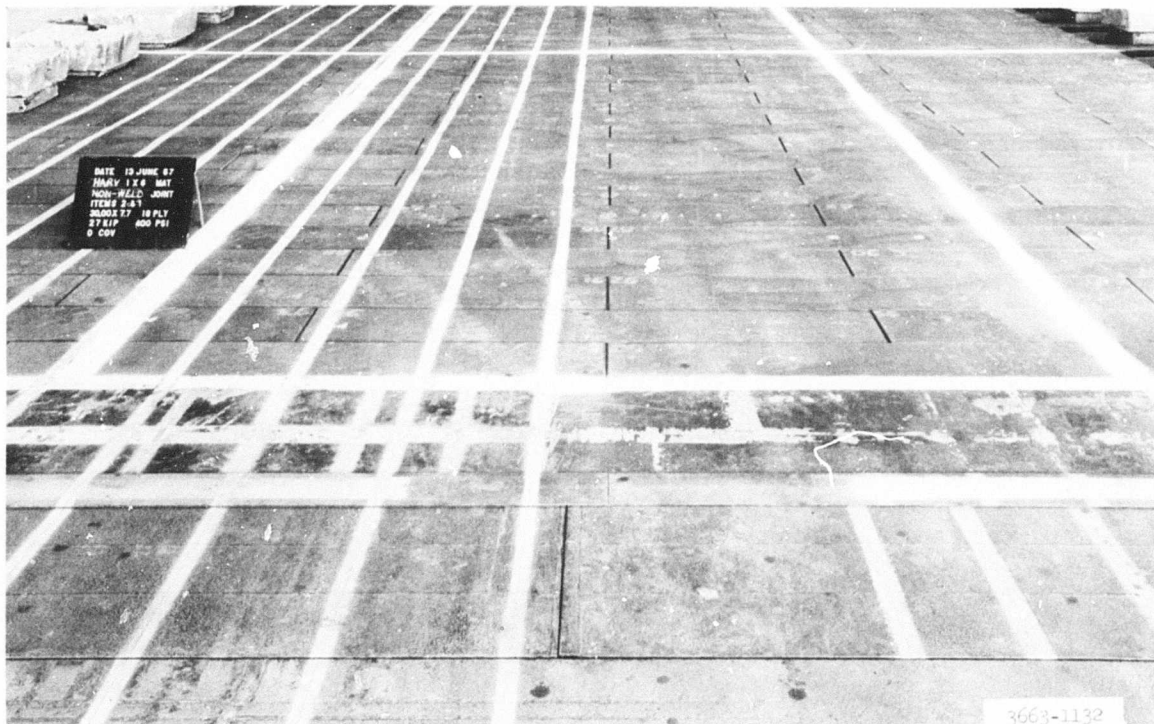
Photograph 1. Test section 1 prior to traffic

24. A general view of test section 1 is shown in photograph 1. After 10 coverages, the ends of the mat were slightly curled due to the planks flexing under traffic. At 48 coverages, the mat had moved longitudinally causing a slight bow in the transverse joints. There was approximately 2-1/2 in. of bow, as shown in photograph 8, due to the longitudinal movement of the mat after 100 coverages. Planks 27, 31, and 32 in item 1 showed a dish of about 3/16 in. along the center line after 150 coverages.

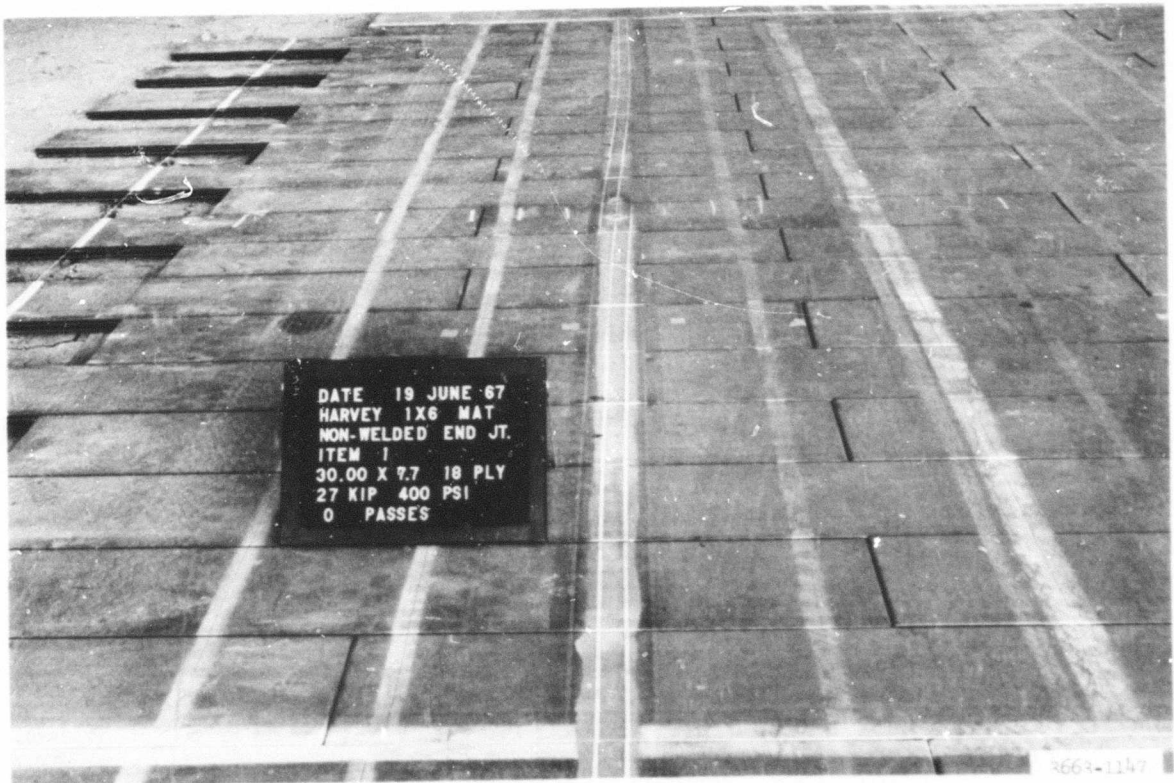
Photograph 12. Item 1, lane 2, prior to single-line traffic

29. The anchor weights were removed from the east edge of the mat before single-line traffic was applied. The traffic lane was located 1-1/2 ft from mat end joints. A general view of item 1 prior to traffic is shown in photograph 12. The mat planks had to be realigned at 760 passes as a result of lateral movement. Both items in the test section withstood 1600 passes of traffic with no apparent mat damage. A view of the test section after traffic is shown in photograph 13. The permanent mat deformation as determined from level readings taken at the end of traffic was 0.4 in. in item 1 and 0.2 in. in item 2.

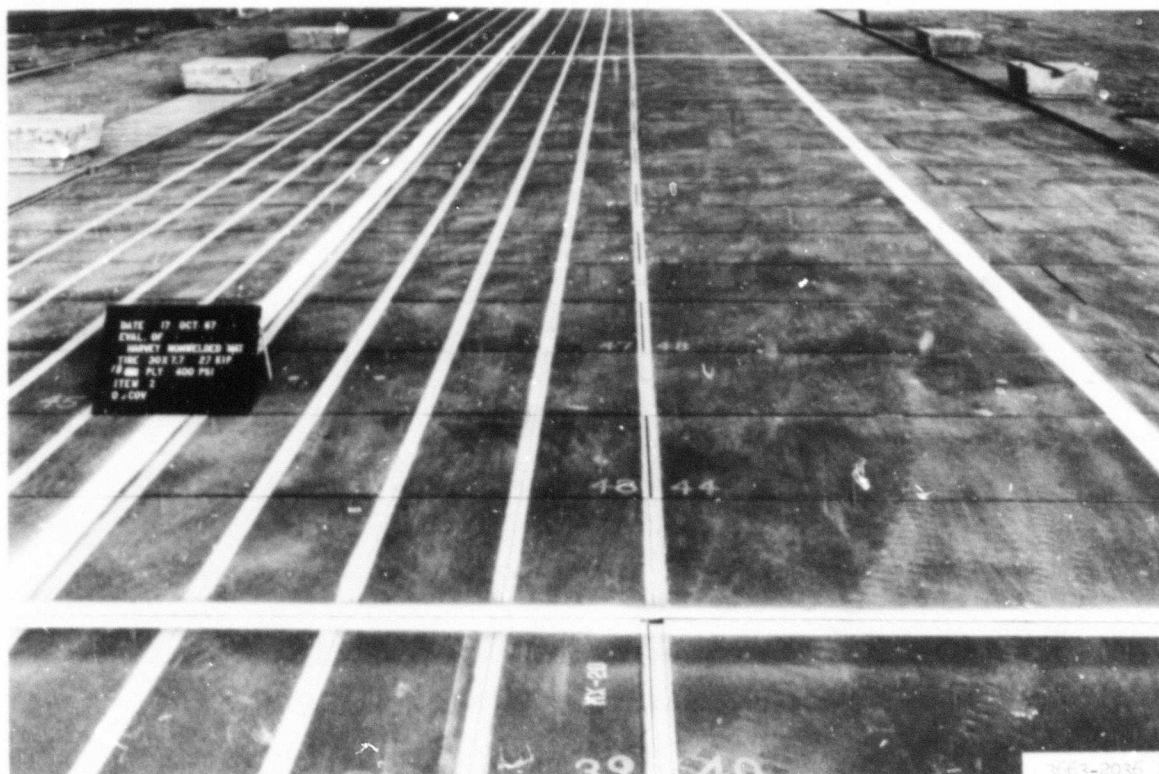
Photograph 15. General view of item 2, section 2, prior to traffic

32. A general view of item 2 prior to traffic is shown in photograph 15. Severe dishing in the mat occurred in runs that consisted of two full planks where the end joints were coincident with the center line of the traffic lane. Severe dishing and broken ribs were noted at the ends of the planks. This damage was caused by the reduced stiffness inherent in the design of the nonwelded end joints, not by breaks or shears of the end joints themselves; i.e., the integral end connectors appeared to be more flexible than the standard welded end connectors. After 10 coverages, a dish of $\frac{3}{16}$ in. had developed at the end joints of planks 43 and 55. As the traffic test progressed, the dish in the mat increased. When traffic was stopped at 187 coverages, the dish in the 20 planks with end joints at the center of the traffic lane was approximately $\frac{1}{2}$ in. The only other visible mat damage was an $\frac{11}{32}$ -in. skin tear on plank 43.

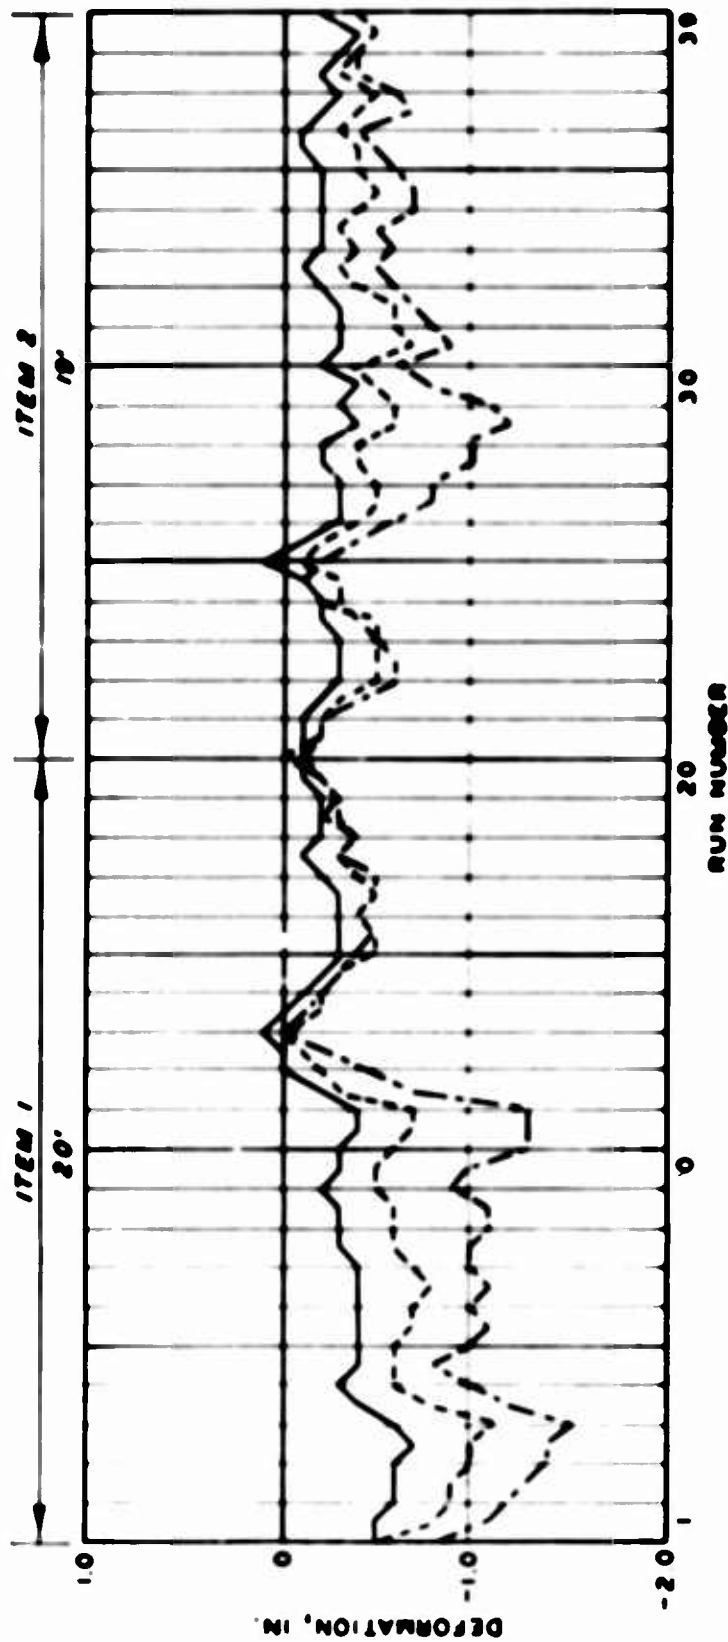
PROFILES ALONG CENTER LINE
UNIFORM-COVERAGE TRAFFIC LANE
TEST SECTION 1

28. Level readings were taken prior to, during, and after traffic. These data indicate that the greatest permanent deformation occurred in item 1. The maximum deformation measured was 0.6 and 0.5 in. for items 1 and 2, respectively, at the end of 188 coverages of traffic. After 298 coverages of traffic, the maximum deformation had increased to about 1.2 in. in item 1 and to 0.7 in. in item 2. A plot indicating deformation along the center line of the traffic lane is shown in plate 5.

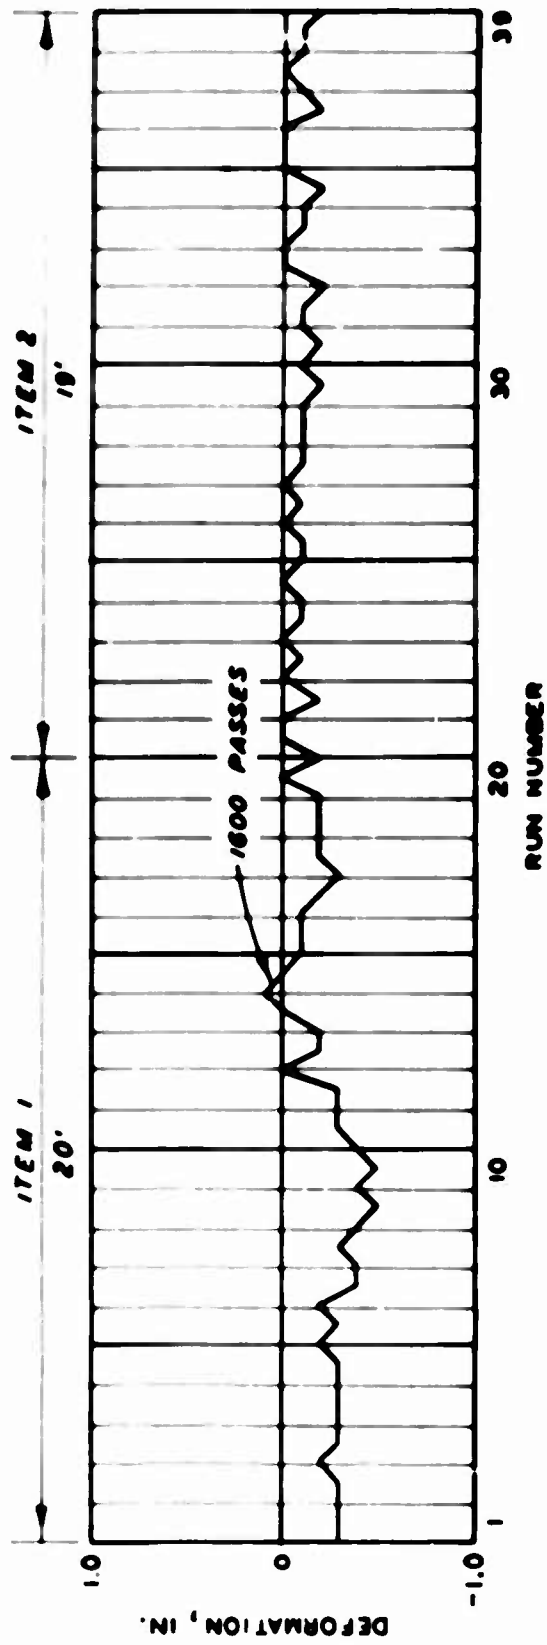
PROFILE ALONG CENTER LINE
SINGLE-LINE TRAFFIC LANE
TEST SECTION I

A profile of mat deformation along the traffic path is shown in plate 6.
